RE: 86 North Winooski Avenue - Demolition of Rear Structure

2. Report of Rear Structure:

Exhibit A: Photography from Site Visit, November 10th, 2021

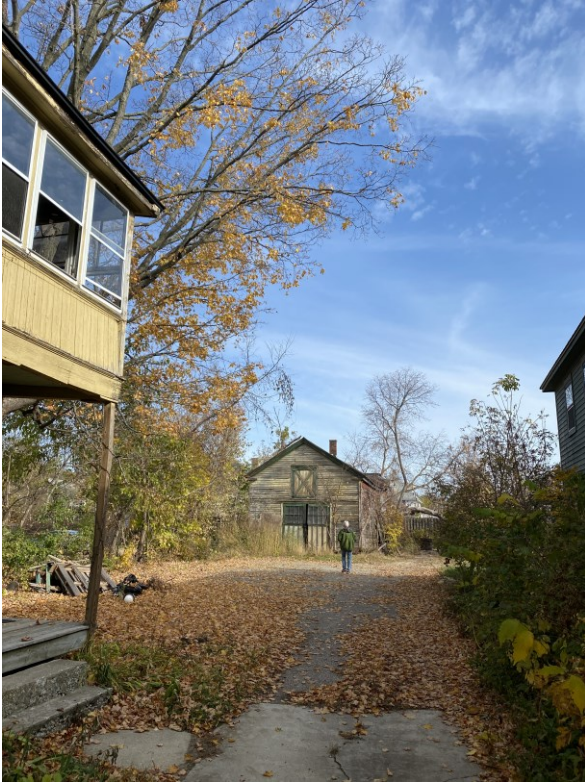
Photo 1. West Elevation from Driveway

- J. There are only insignificant vestiges of the eaves, trim and windows that remain. The front doors on the west façade have limited potential for salvage.

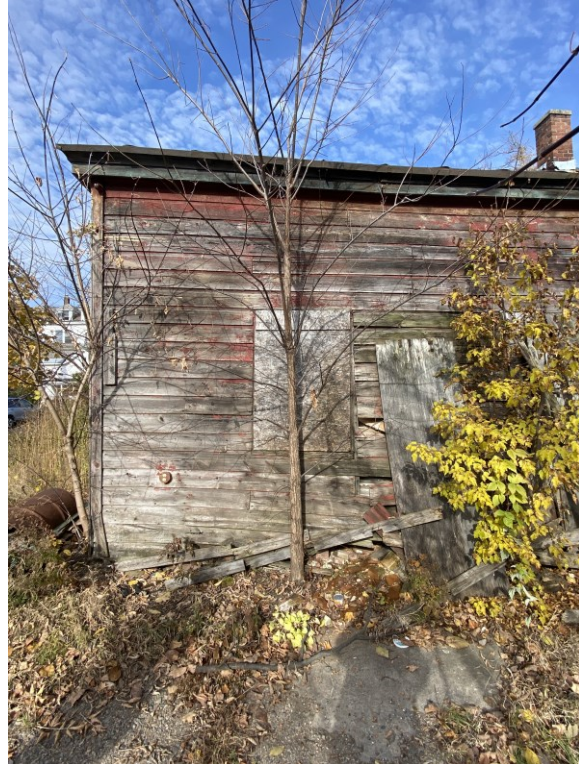
Photo 4. Partial South Elevation

- G. The sills of the walls are deteriorated or non-existent.
- H. The longer north wall and remaining portions of the south walls have clear bowing and deformation due to poor connection to proper foundation and inadequate structure.

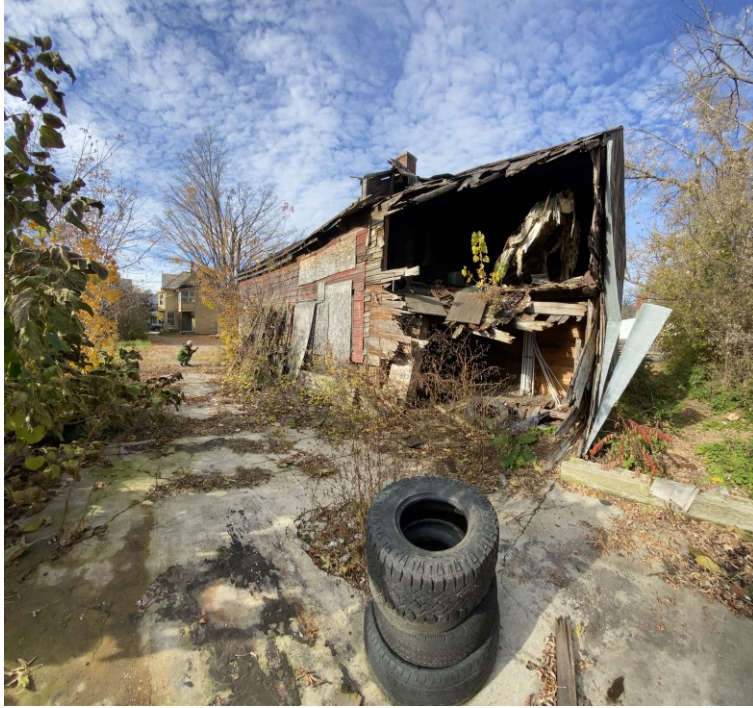
Photo 5. South East Perspective (Collapsed Structure)

- D. Entering into the structure, clear indications of fire-damage on roof, roof beams, walls and floor.
- E. Collapse of second level towards the rear of the property show existing roof structural members are undersized and insufficient. Rehabilitation of the existing structural members will not adequately provide safe and sufficient support.

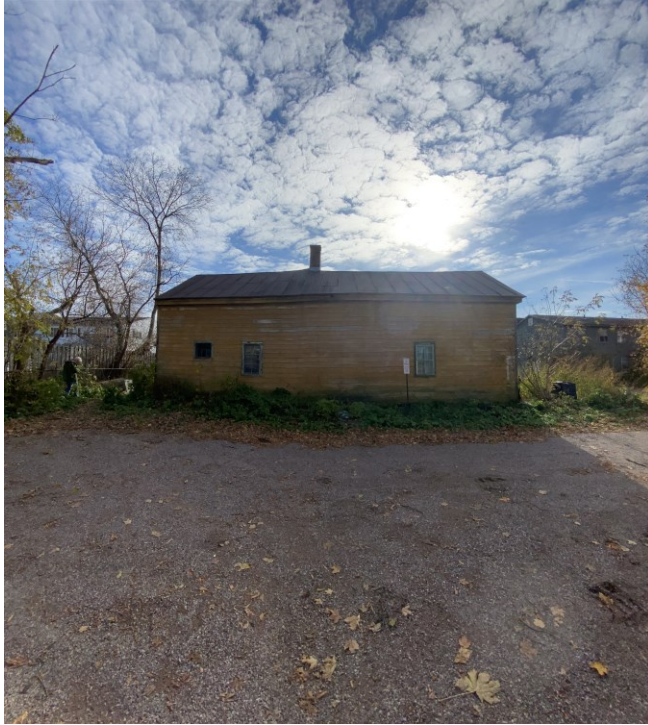
Photo 7. North Elevation (From adjacent property)

- I. The materials on the structure appear to be in complete disrepair. Siding on the east portion of the building has been replaced by tin corrugated siding. The north elevation appears to have been substituted with another *non-original* material.
